# Minimally Invasive Restoration of Maxillary Incisors with Combined Erosion and Attrition: A Case Report

Case Report

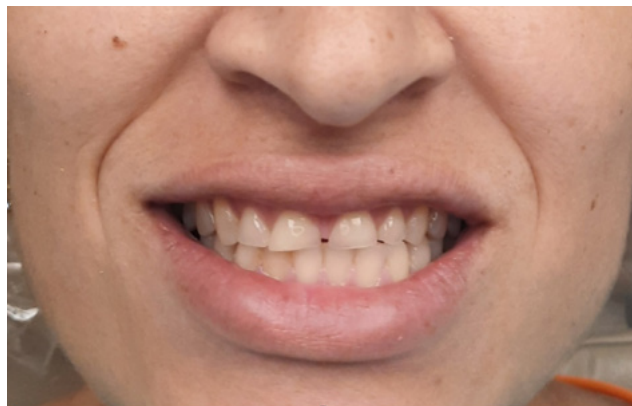
**Figure 1:** Preoperative Smile view.

Clinical and radiographic examinations revealed approximately 40% incisal length loss in the maxillary incisors, corresponding to a Smith and Knight Score 3 (loss of enamel and substantial dentin exposure, without pulpal involvement) [5] (Figures 1-3). Palatal surfaces exhibited complete enamel loss with a narrow peripheral band intact—critical for adhesive bonding. This presentation was consistent with ACE Class IV (loss of palatal enamel, >2 mm incisal loss, no pulp exposure) [6] (Figure 4).

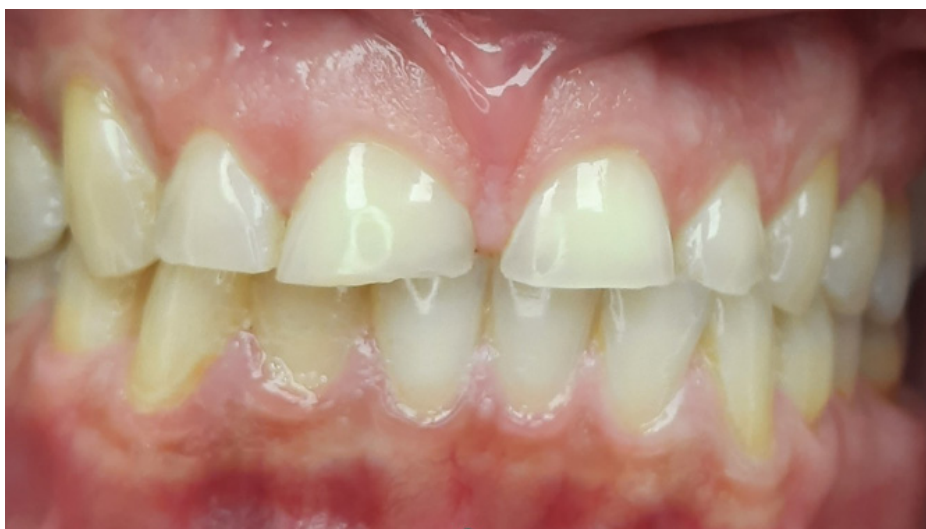
(GERD) but admitted to frequent soda consumption and nocturnal bruxism. Her midline diastema has relapsed after previous orthodontic closure. A broad labial frenum extended close to the interdental papilla (Figure 2). The mandibular incisors showed signs of attrition

**Figure 2:** Preoperative Intraoral Frontal view showing midline diastema and lower incisal edge position.

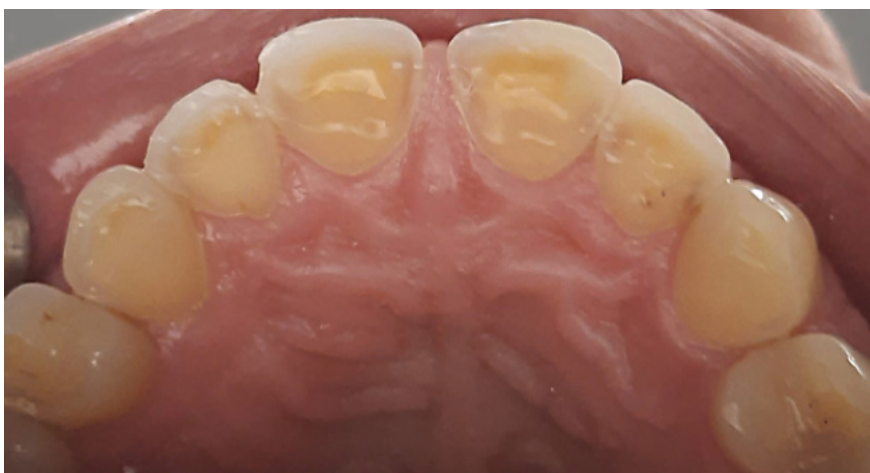
**Figure 4:** Preoperative Intraoral Palatal view showing severe wear of the anterior teeth.

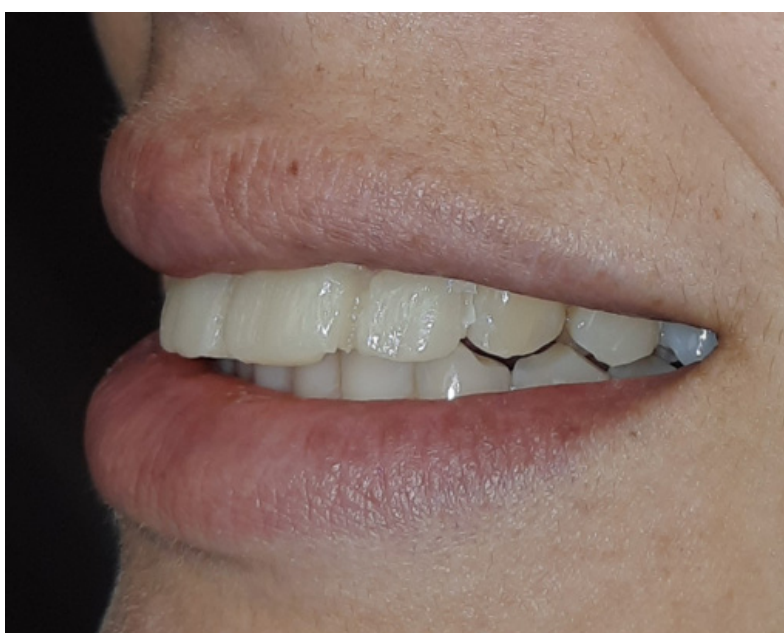
**Figure 5:** Left Profile view of the Mock-up showing the proposed overjet and overbite.

graphs, and photographs. Using a silicone putty index (Speedex Putty, Coltene), an intraoral mock-up was performed with bis-acryl material (Structure 2, Voco) for esthetic and functional preview (Figure 5).

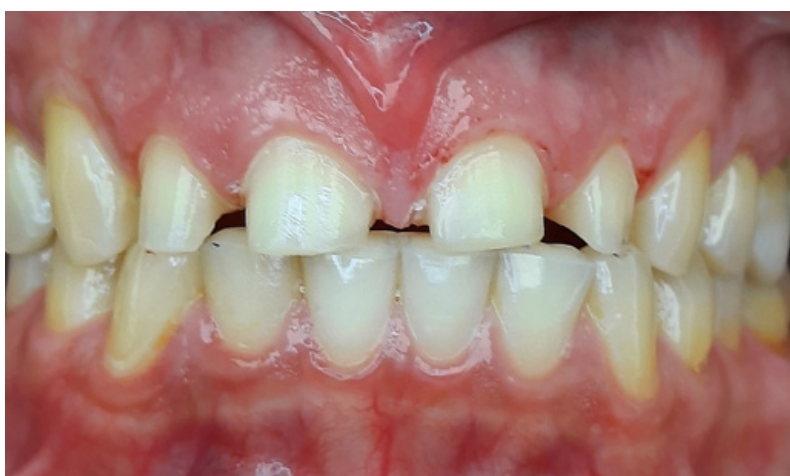
**Figure 6:** Anterior view of tooth preparations showing the available interocclusal space.

Following patient approval, conservative tooth preparations were performed according to the additive design. Minimal enameloplasty was performed on the incisal edges of mandibular incisors to create an acceptable restorative space (~1mm) [7]. Provisional crowns were fabricated with bis-acryl resin and delivered using the silicone matrix. The patient was instructed to report any functional or esthetic concerns (Figures 6,7).

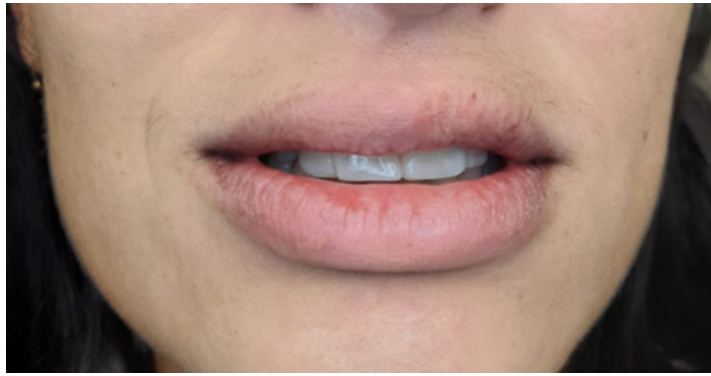
Figure 7: Provisional Restorations- Extraoral view.

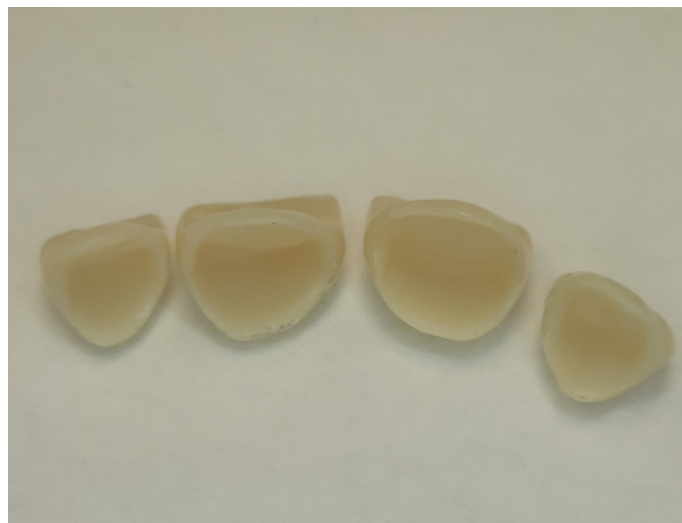
Figure 9: Definitive Restorations showing the relative thickness of the palatal ceramic.

At the follow-up, preparations and provisionals were reevaluated and digitally scanned using an intraoral scanner (iTero Lumina). The dental laboratory was instructed to fabricate porcelain-fused-to-zirconia (PFZ) crowns, combining a zirconia substructure with feldspathic porcelain veneering. 3Y zirconia was selected for its high flexural strength (1200 MPa) and fracture toughness ( $\sim 5-6 \text{ MPa}\cdot\sqrt{\text{m}}$ ) [7], making it ideal for cases with limited restorative space and functional load. Feldspathic porcelain offered excellent esthetics through translucency, fluorescence, and shading customization (Figure 9).

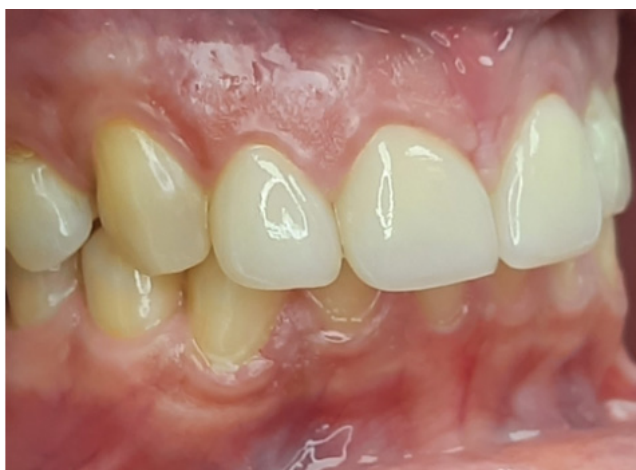
**Figure 11:** Postoperative Right view in MIP.

This case highlights the comprehensive management of advanced erosive tooth wear using contemporary high-strength ceramic materials. The main challenges included limited remaining tooth structure, minimal interocclusal space, midline diastema, and high esthetic demands. PFZ crowns offered an ideal solution, balancing esthetic with mechanical performance. Proper diagnosis, additive treatment planning, and effective communication with the patient were essential to treatment success (Figures 10-16).

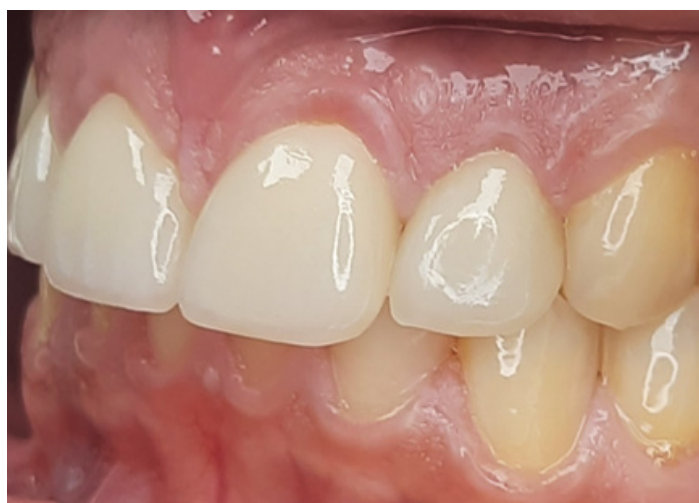
**Figure 12:** Postoperative left view in MIP.

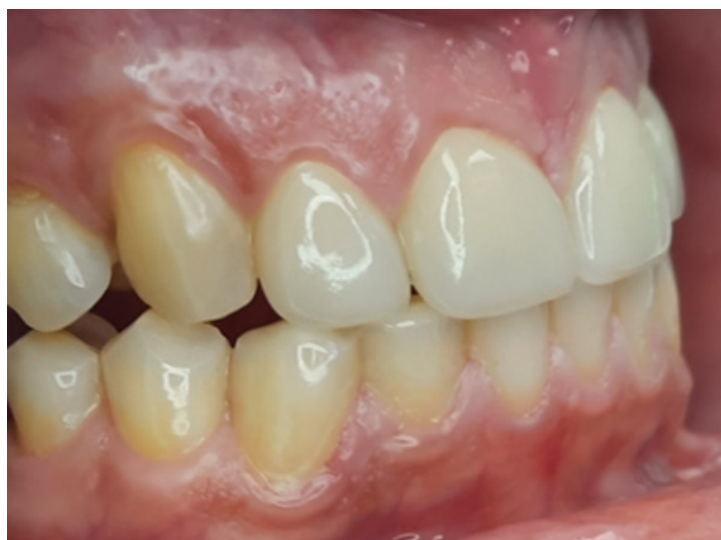
**Figure 13:** Postoperative intraoral right protrusive view.

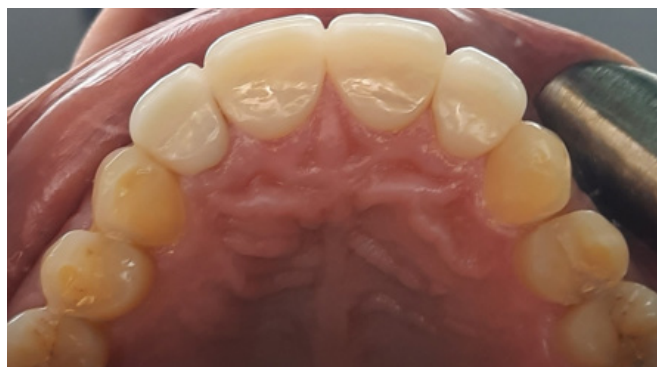
**Figure 14:** Postoperative Palatal view.

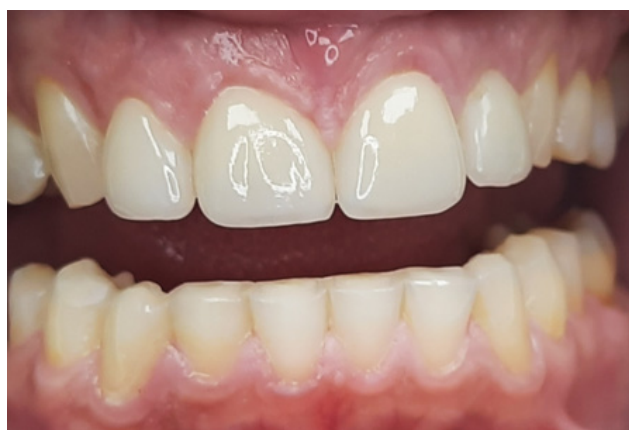
**Figure 15:** Postoperative view showing the conservative Enameloplasty of mandibular incisors.
